# TEST REPORT

**REPORT NUMBER: 3161466SAT-007**  
ORIGINAL ISSUE DATE: November 6, 2008  
REVISED DATE: N/A

PRODUCT EVALUATED: SEALECTION Agribalance® 7" walls and 11 1/4"  
ceiling with 1/4" plywood  
EVALUATION PROPERTY: Heat Release, Flame Spread

**Report of testing SEALECTION Agribalance® with 1/4" plywood for compliance with the applicable requirements of the following criteria: NFPA 286 for the establishment of a (BASELINE) for testing of alternative ignition barriers in accordance with AC 377 Appendix A.**

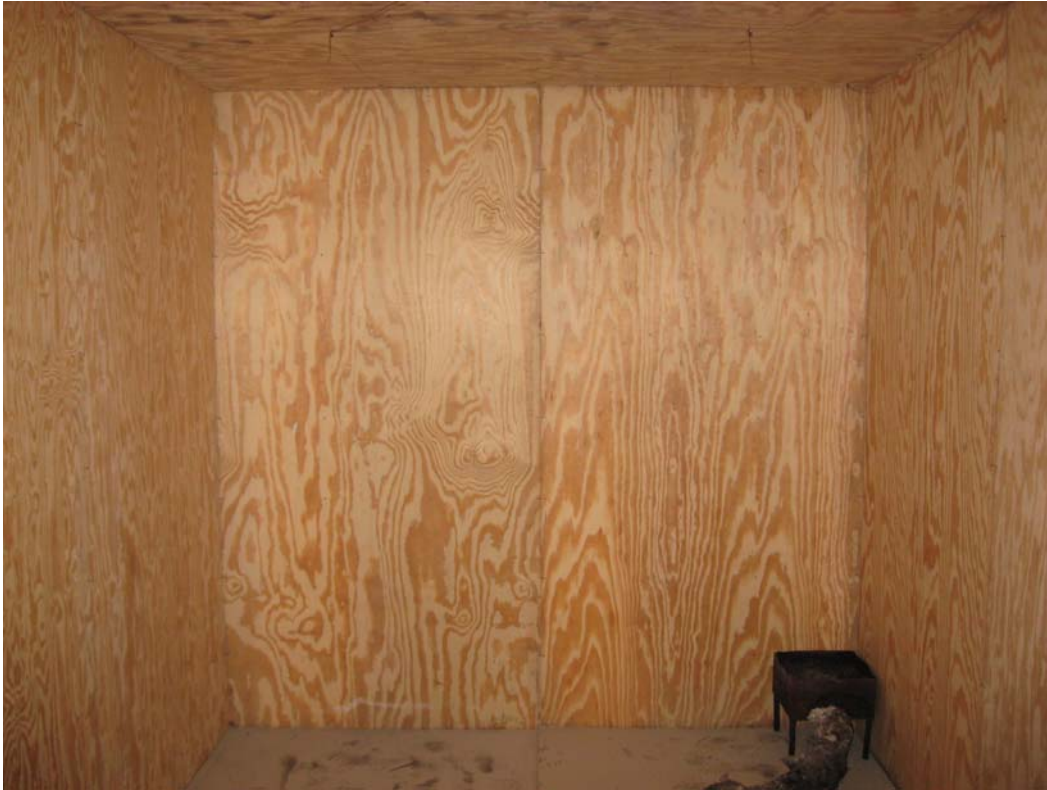
Pre-test photo back wall

The test specimen consisted of three walls with 2x8 studs, 16 inches o.c. and 2x12 joists, 24 inches o.c. with a 15/32 inch plywood backing. The final interior dimensions were 8 feet high, 8 feet wide and 12 feet deep. Ceiling joists ran parallel to the short dimension of the room. The corner was constructed such that two studs met at their edges, forming a 90° angle.

On top of this substrate, the spray foam was applied to a thickness of 7 inches on the walls and 11 inches on the ceiling. There was no significant over spray outside of the cavities. The wall foam, studs, ceiling foam and joists were covered with ¼ inch plywood was applied as 4 foot x 8 foot vertical sheets on the walls. The ceiling was covered with three 4 foot x 8 foot sheets with the seems running parallel to the short dimension of the room.

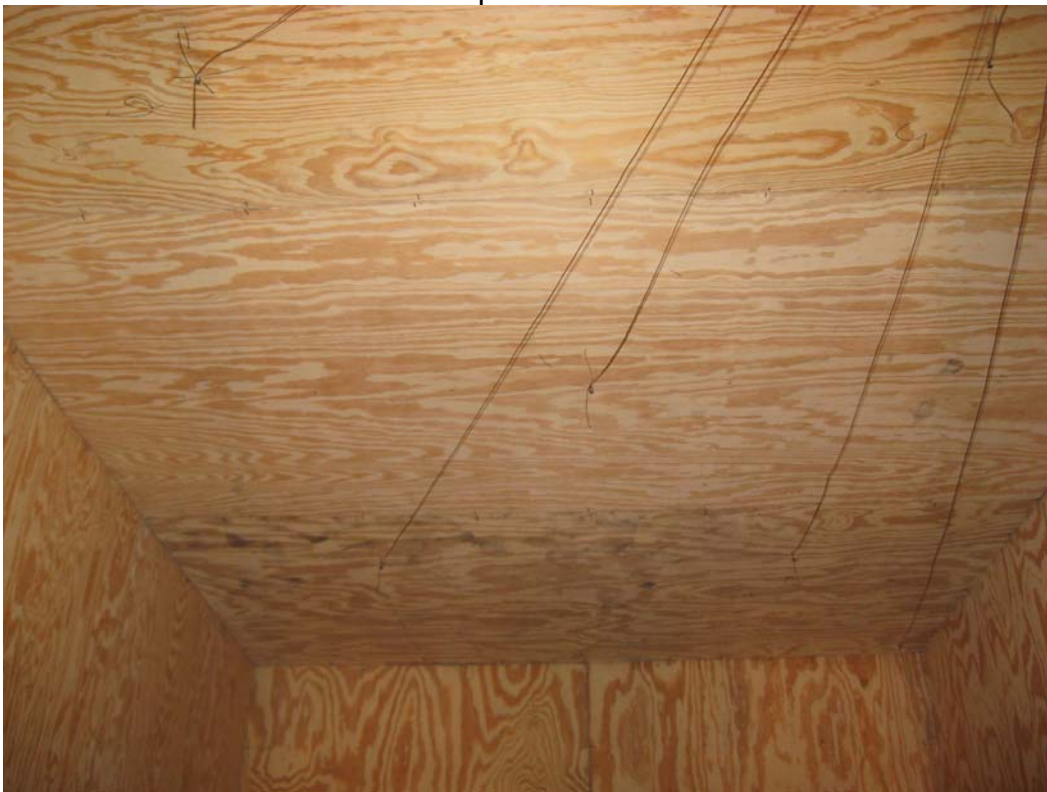
Pre-test photo ceiling

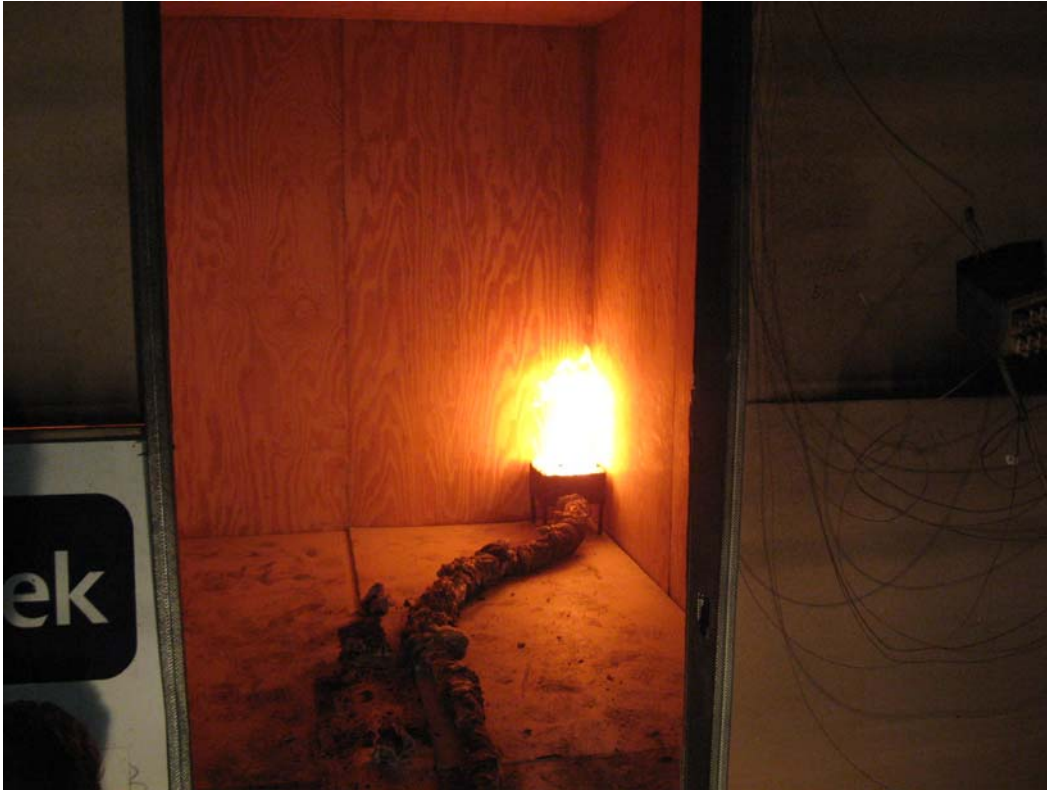
Start of test. 40kW

<b>TIME</b>	
<b>(min:sec)</b>	<b>OBSERVATION</b>
0:00	Ignition of burner. Heat output set to 40 kW.
1:01	The walls began to discolor.
1:31	The walls ignited.
1:55	Flame tips reached the ceiling.
2:53	The ceiling ignited (Fail)
3:40	Flames reach the 8 foot extremity
4:29	Flames exited through the doorway. Test terminated.

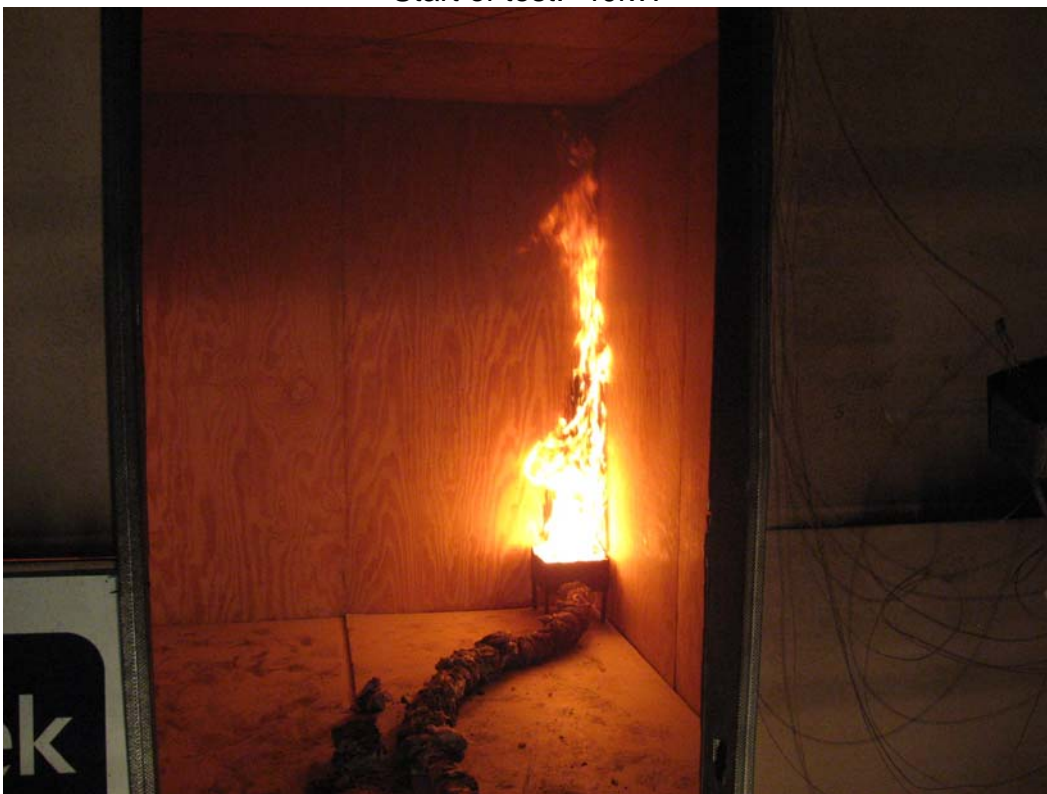
Test photo. Ignition.

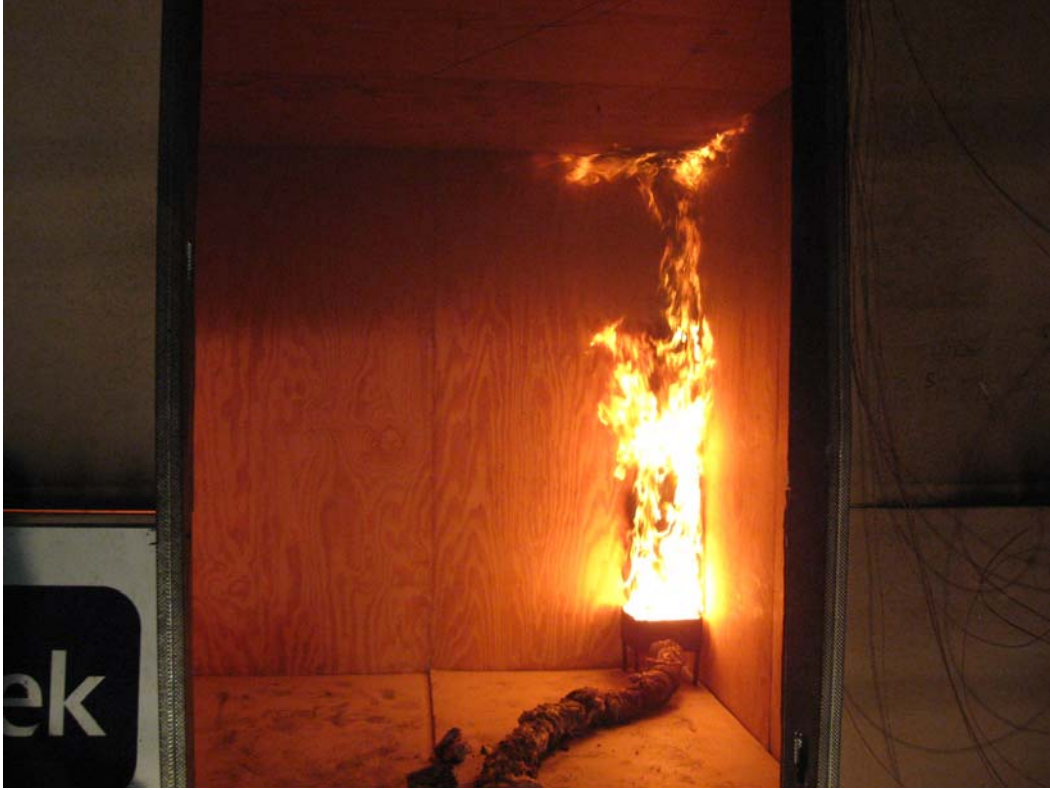
Test photo. Flames on the ceiling.

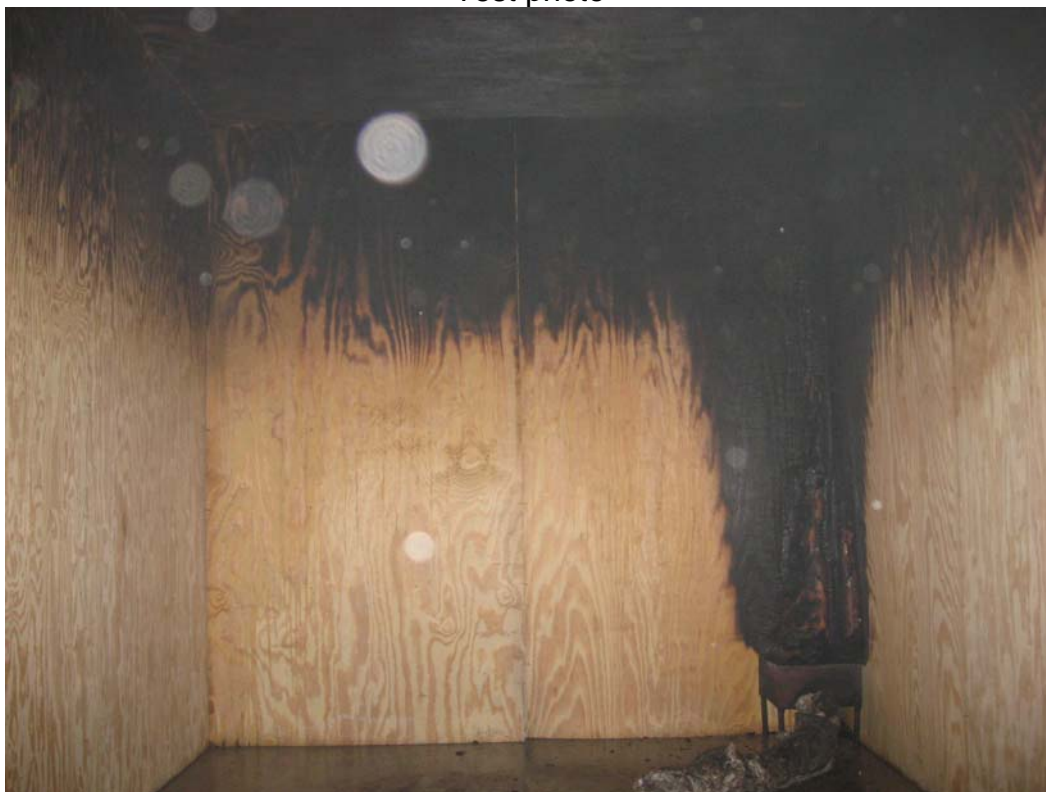
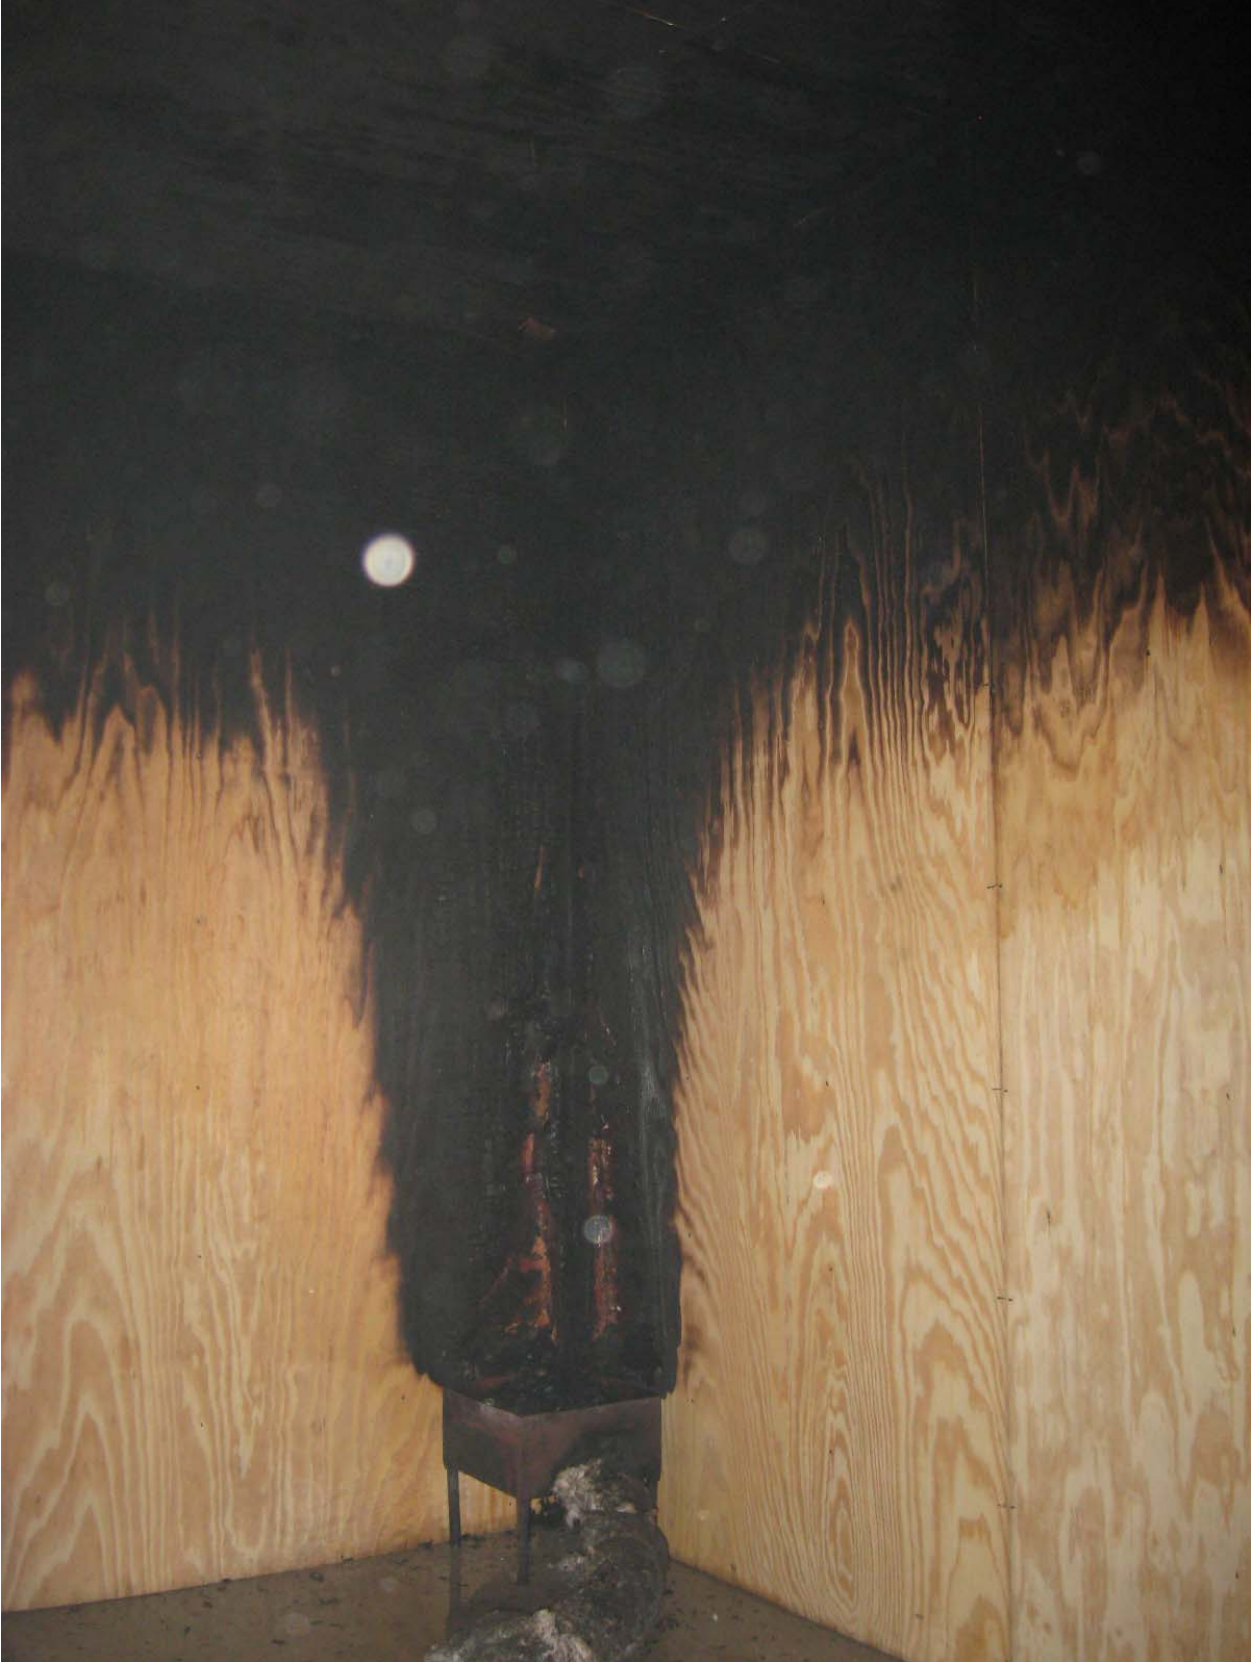
Post-test photo

The plywood was heavily charred. In the area near the burner, foam was exposed.

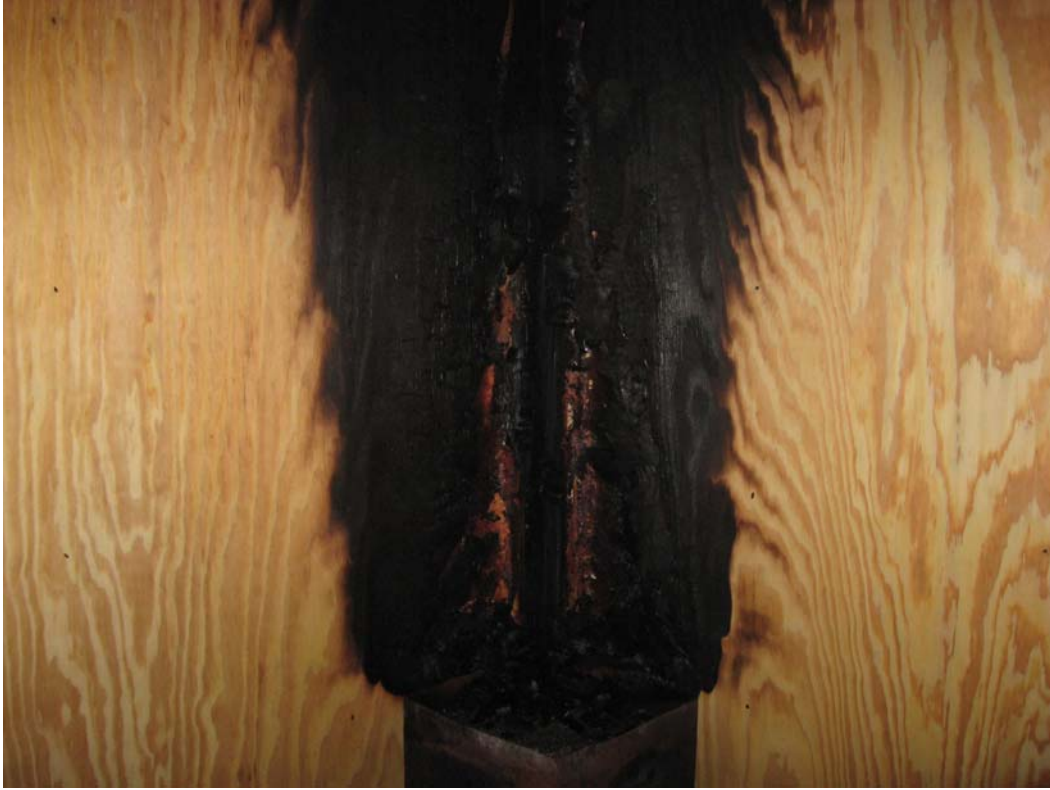
Detail of corner
