TEST REPORT

REPORT NUMBER: 3179554-SAT-A
ORIGINAL ISSUE DATE: May 29, 2009
REVISED DATE: N/A

PRODUCT EVALUATED: Heatlok soy 2lb closed cell foam 9 " sidewalls and 13" ceiling rafters coated with 14 mils of Fireshell® F10E intumescent coating
EVALUATION PROPERTY: Heat Release, Flame Spread

Report of testing Heatlok Soy 2lb closed cell foam with 14 mils of Fireshell® F10E for compliance with the applicable requirements of the following criteria: NFPA 286 with the acceptance criteria of ICC-ES ACC377 Appendix A

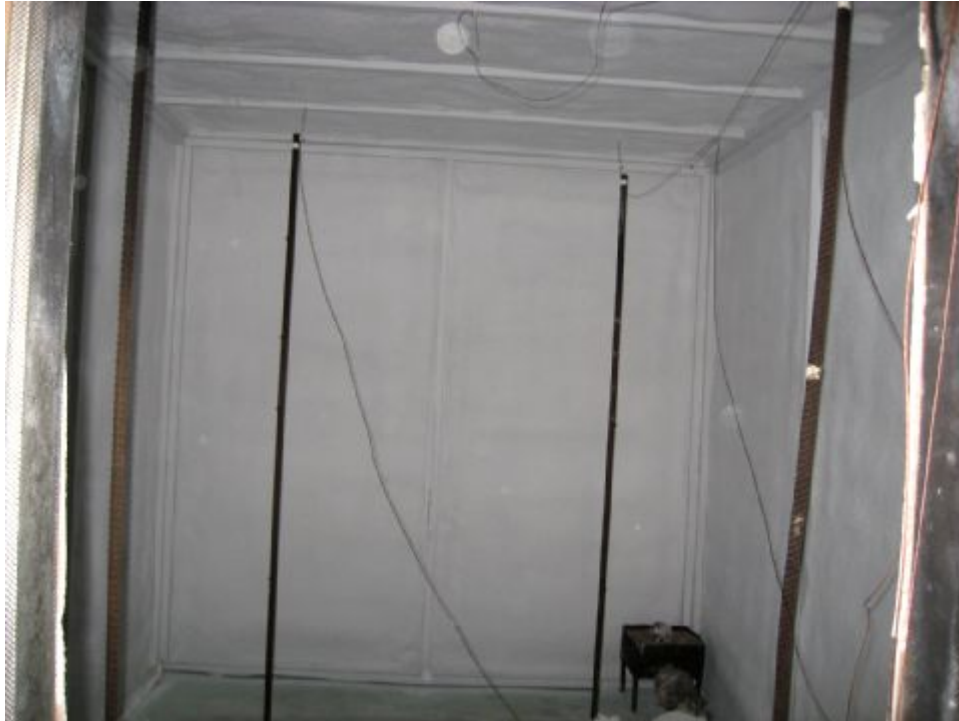
Pre-test photo back wall

The test specimen consisted of three walls with 2x9 studs, 48 inches o.c. and 2x13 joists, 24 inches o.c. with a 15/32 inch plywood backing. The final interior dimensions were 8 feet high, 8 feet wide and 12 feet deep. Ceiling joists ran parallel to the short dimension of the room. The corner was constructed such that two studs met at their edges, forming a 90° angle.

On top of this substrate, the spray foam was applied to a thickness of 8 inches on the walls and 12 inches on the ceiling. There was no significant over spray outside of the cavities. The wall foam, studs, ceiling foam, and joists were covered with 14 mils of F10E intumescent coating.

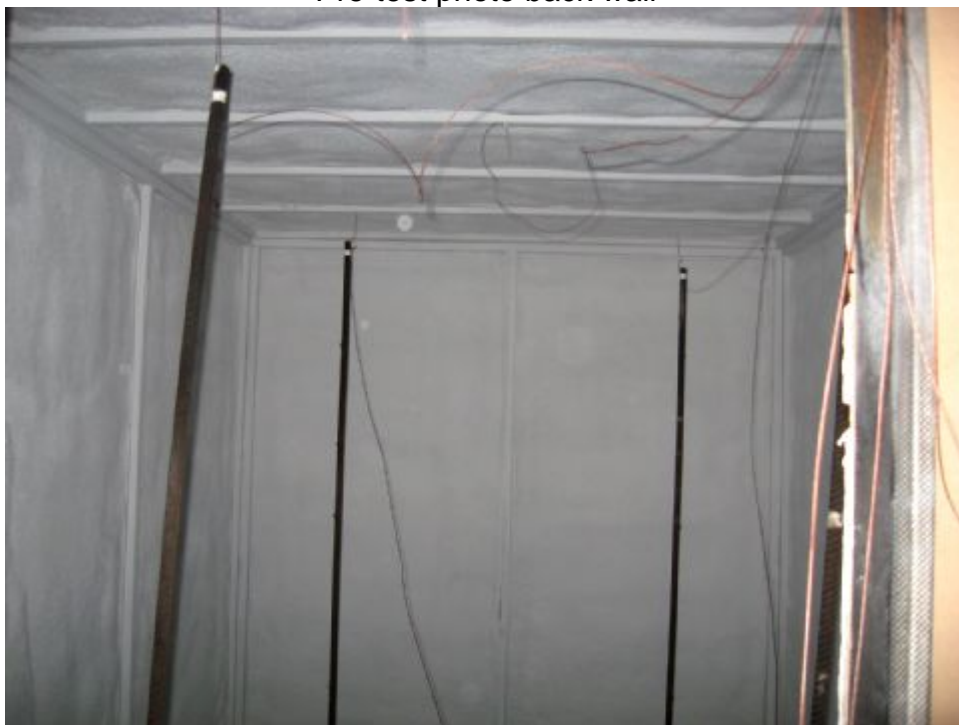
Pre-test photo ceiling

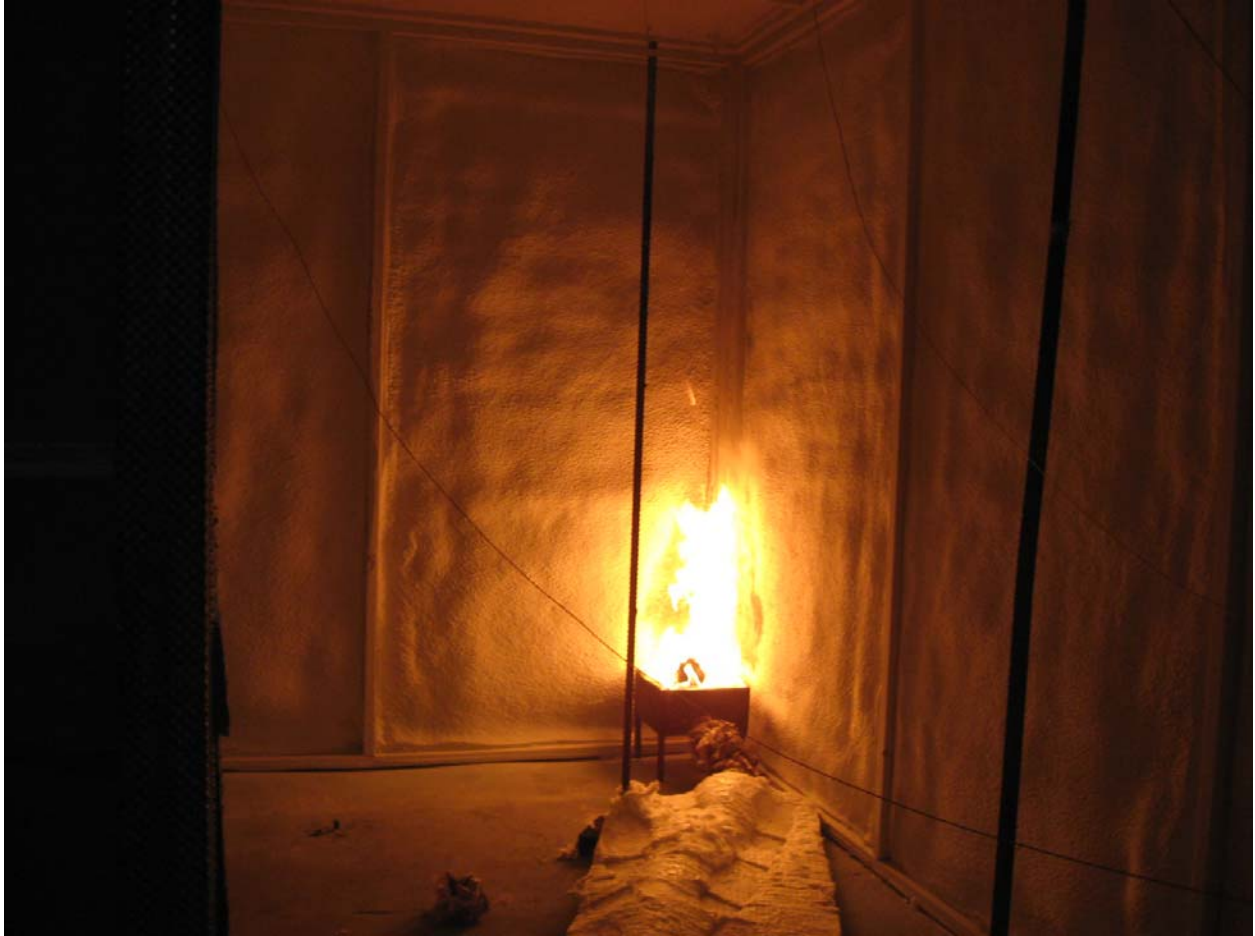
Start of test. 40kW

TIME	
(min:sec)	OBSERVATION
0:00	Ignition of burner. Heat output set to 40 kW.
0:30	The walls began to discolor.
0:42	There is light smoke.
1:18	The side wall ignited.
1:42	Heavy smoke.
5:00	Burner was increased to 160 KW.
5:21	Flames are spreading horizontally at 4ft on back wall..
5:42	Flames spreading vertically and horizontally on back wall. (3 to 4ft)
5:54	Flame or at five foot on back wall..
6:04	Flames out the door.
6:42	Test terminated

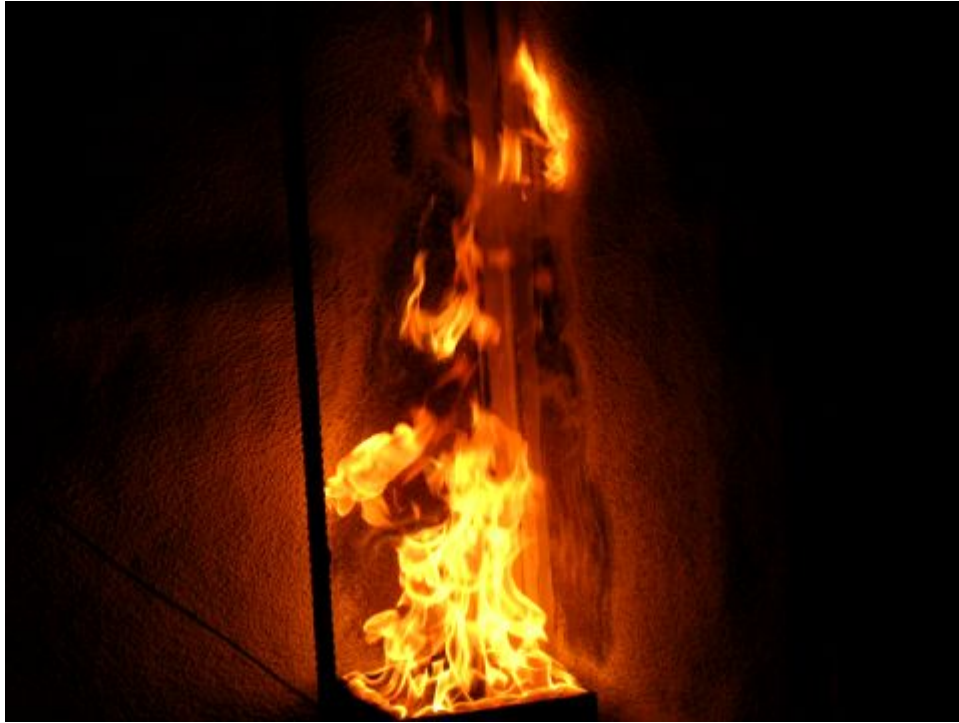
Test photo ignition.

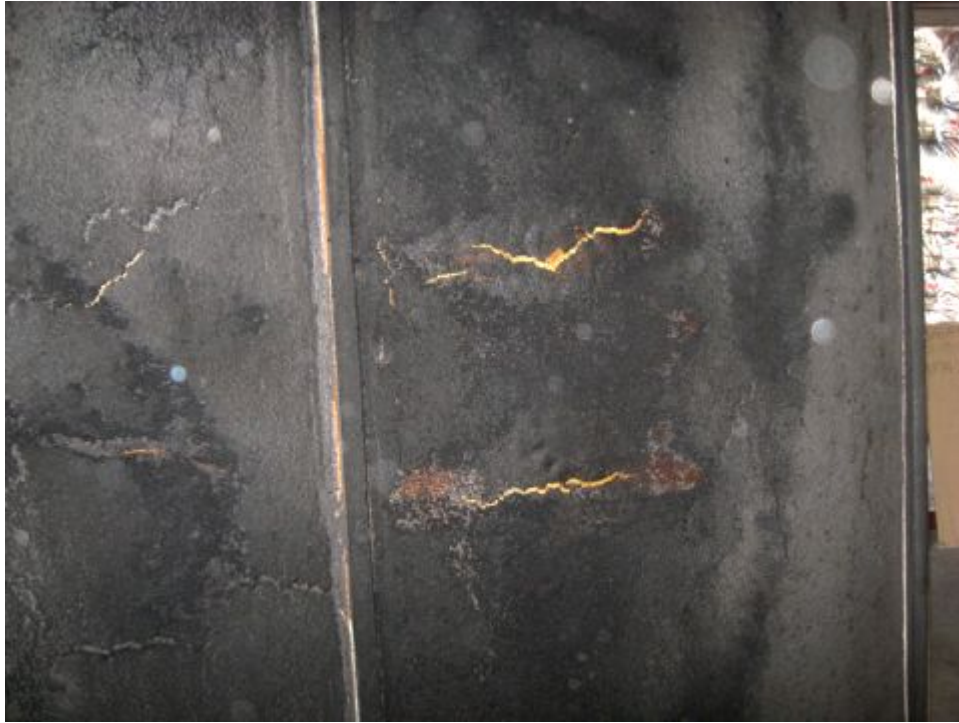
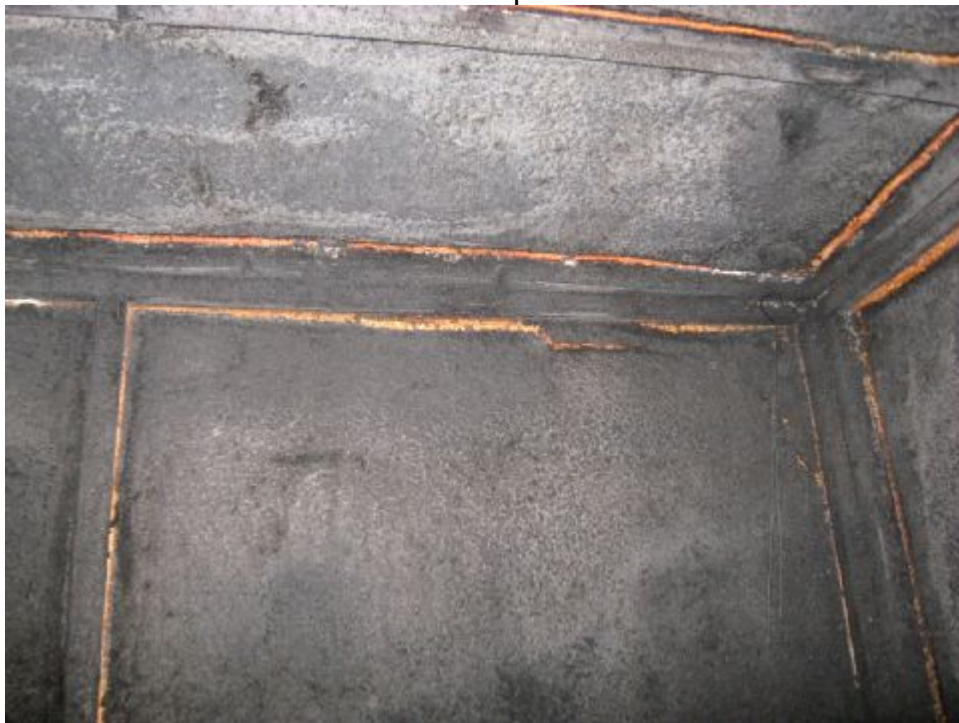
Post-test photo

The intumescent and foam were heavily charred. Depth of a inch.

For additional details, see the post-test photographs later in this report.
