# TEST REPORT

**REPORT NUMBER:3179554-SAT-E**  
ORIGINAL ISSUE DATE: May 29, 2009  
REVISED DATE: N/A

PRODUCT EVALUATED: SEALECTION Agri Balance® Soy Based open cell  
foam and 10 MILS Fireshell® F1E intumescent coating  
EVALUATION PROPERTY: Heat Release, Flame Spread

**Report of testing SEALECTION Agri Balance® Soy Based open cell with 10 MILS of Fireshell® F1E on walls for compliance with the applicable requirements of the following criteria: NFPA 286 with acceptance criteria of. (AC377) Appendix A**

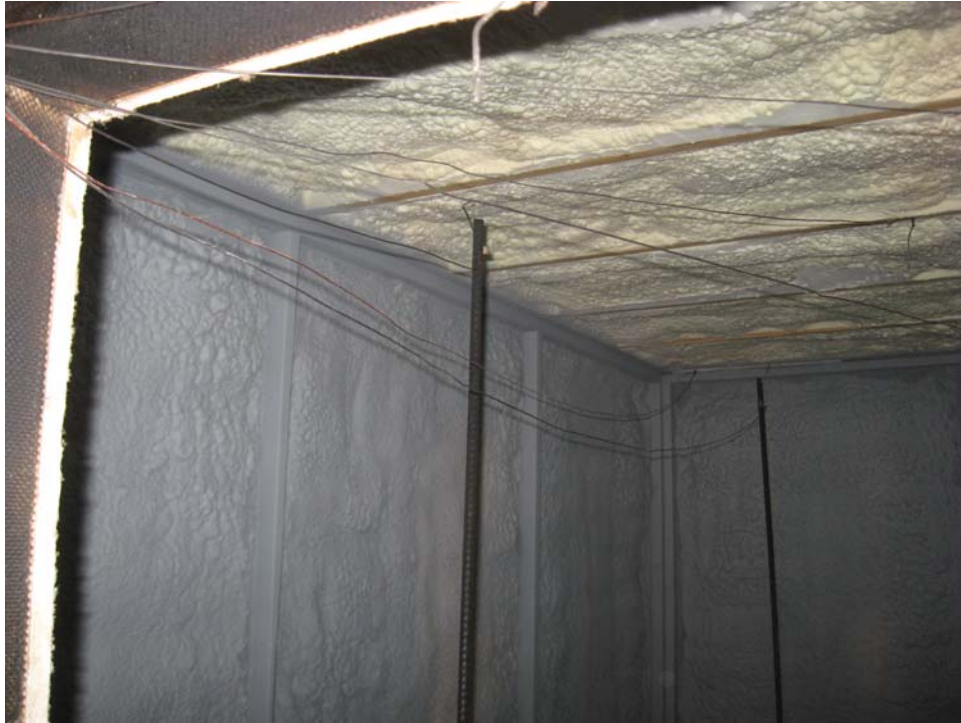
Pre-test photo

The test specimen consisted of three walls with 2x12 studs, 48 inches o.c. and 2x12 joists, 24 inches o.c. with a 15/32 inch plywood backing. The final interior dimensions were 8 feet high, 8 feet wide and 12 feet deep. Ceiling joists ran parallel to the short dimension of the room. The corner was constructed such that two studs met at their edges, forming a 90° angle.

On top of this substrate, the spray foam was applied to a thickness of 10 inches on the walls and 11 1/2 inches on the ceiling. There was no significant over spray outside of the cavities. The wall foam and studs were covered with 10 mils of Fireshell® F1E intumescent coating.

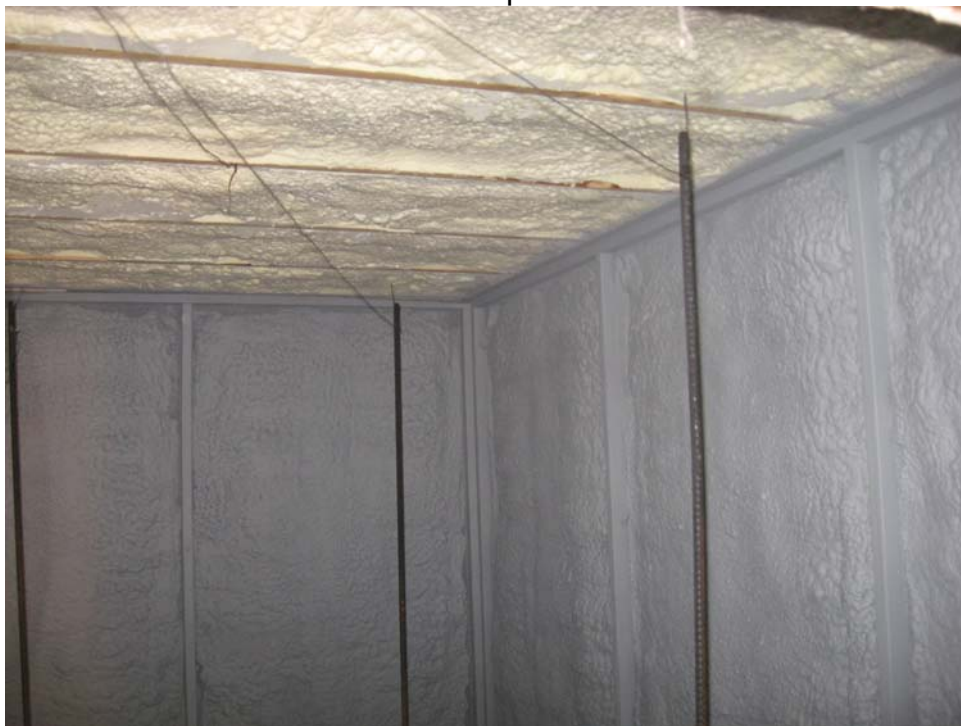
Pre-test photo ceiling

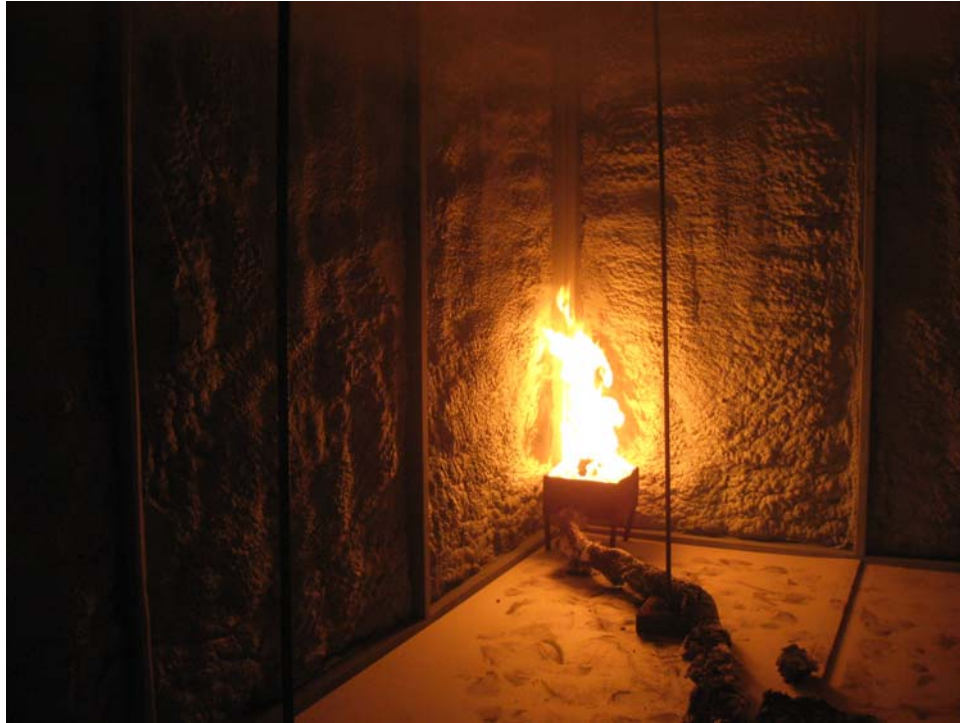
Start of test. 40kW

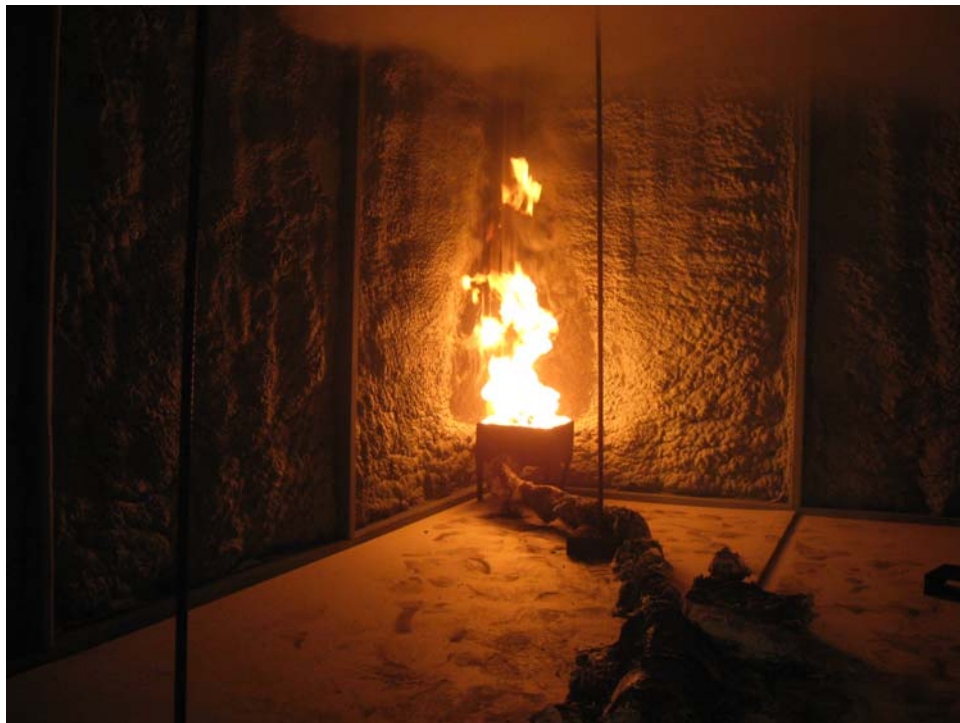
Test photo ignition.

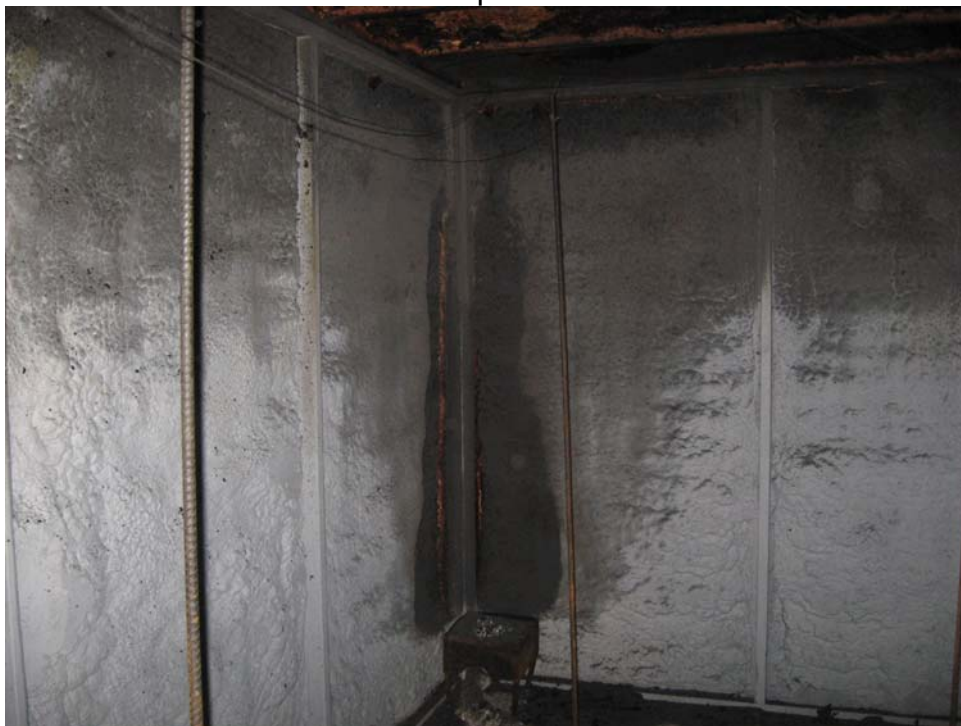
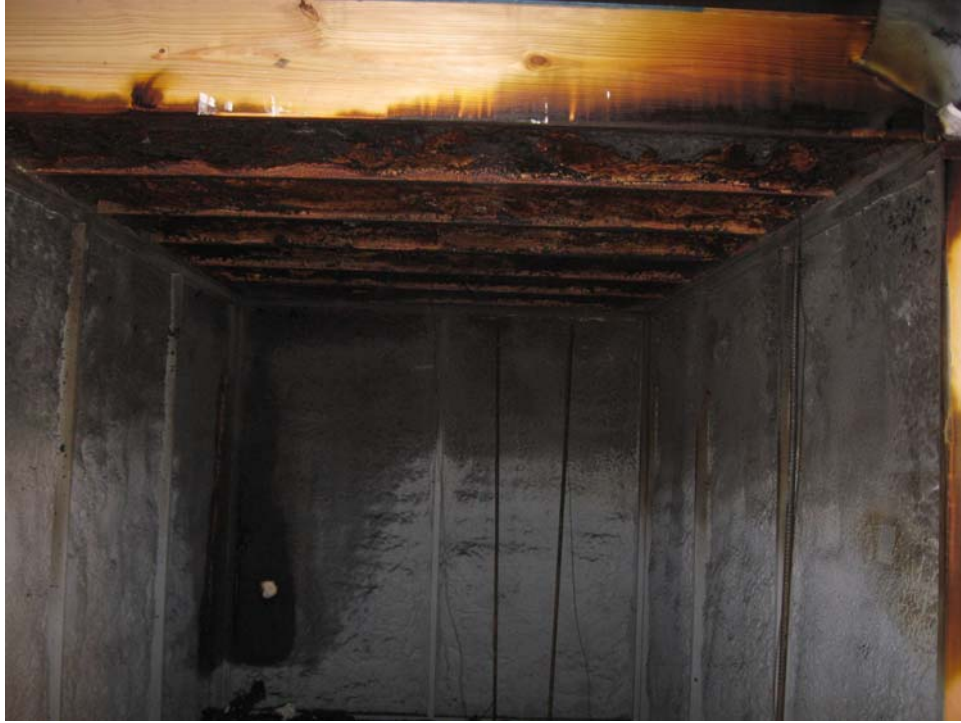
Post-test photo

The intumescent and foam were heavily charred. There 5 ½ inches of foam loss at 4 foot in corner above burner.
